# SEAM WELD IDENTIFICATION

INSIDE LOOK: MMT'S HSD REPORTING

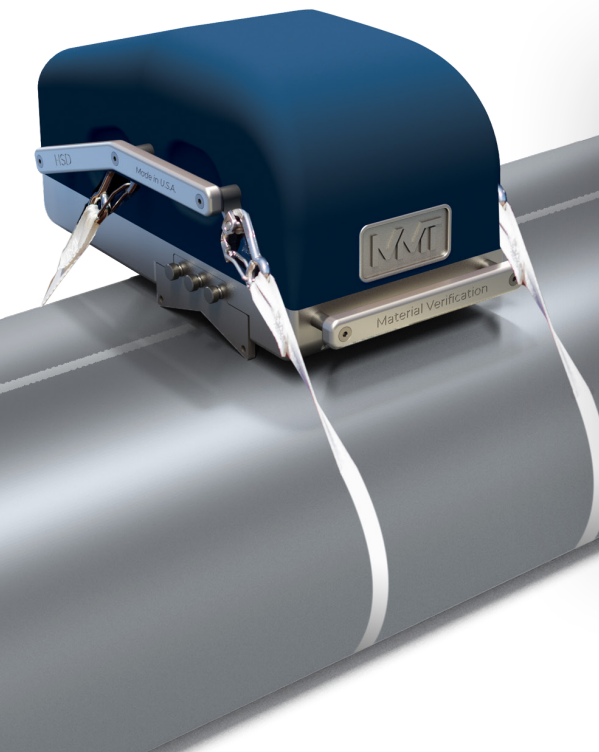
Figure 1 *Incident sample*

MMT's HSD Tester was used to characterize the weld of an LF-ERW pipe joint that had experienced an incident at the seam. A sample of the incident pipe was cut out and tested in a warehouse. The HSD Tester identified a high hardness spike at the bondline that could lead to brittle behavior (Figure 1).

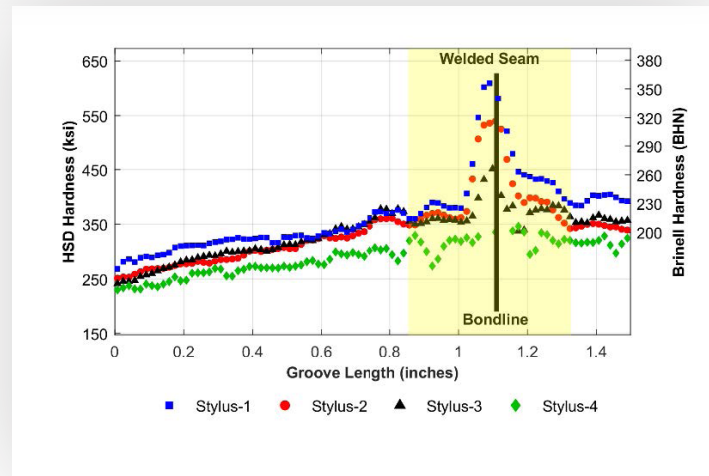
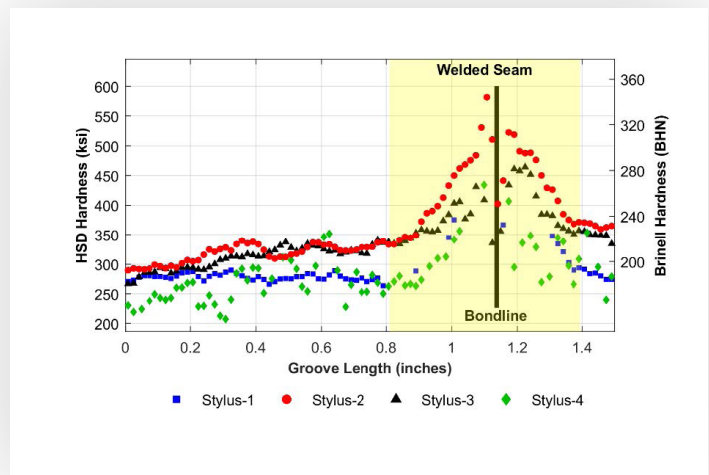
The scope of testing was expanded to include surrounding pipes still in-service by the same manufacturer. Testing results from MMT's HSD were then used as a proactive method to identify potential threats and ensure the integrity of other in-service pipelines. From the expanded testing, one other pipe joint was identified as having a similar hardness spike at the bondline (Figure 2). Because of the early identification, operators prioritized repairs on that pipeline. Other joints that were tested showed smaller increases in hardness and therefore had less risk of exhibiting brittle behavior. All pipe seam welds tested were identified as LF-ERW.

Figure 2 *Field sample with similar hardness increase behavior*
